Materials Laboratory Division

Investigation Into Trans World Airlines Flight 800

Breakup Sequence Presentation

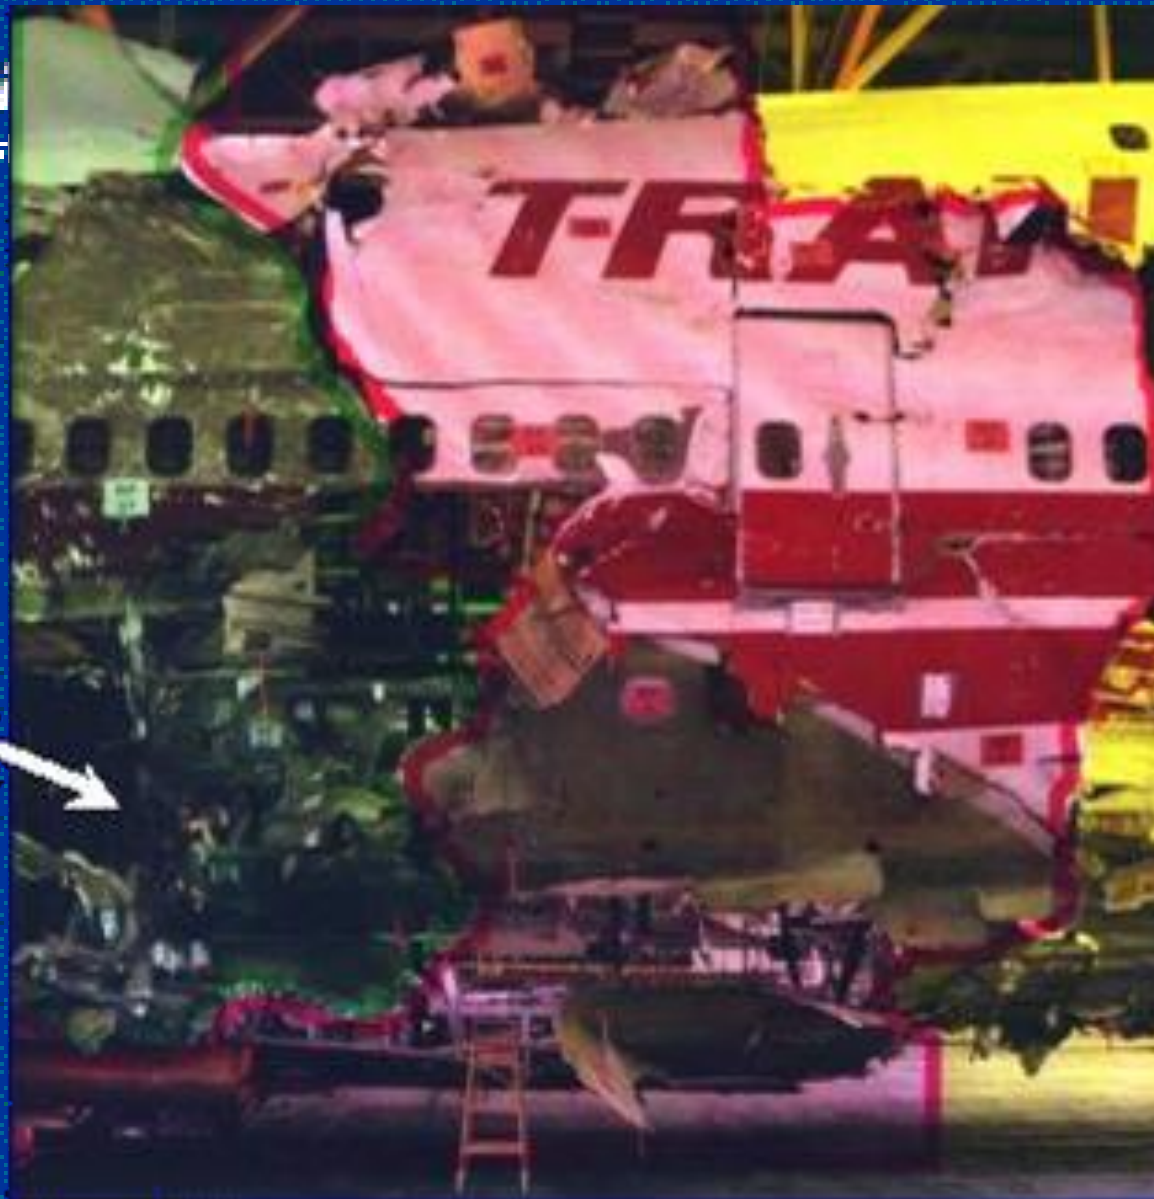
Front
Spar

Spanwise beam 3 fractured at its upper end,
then
rotated forward

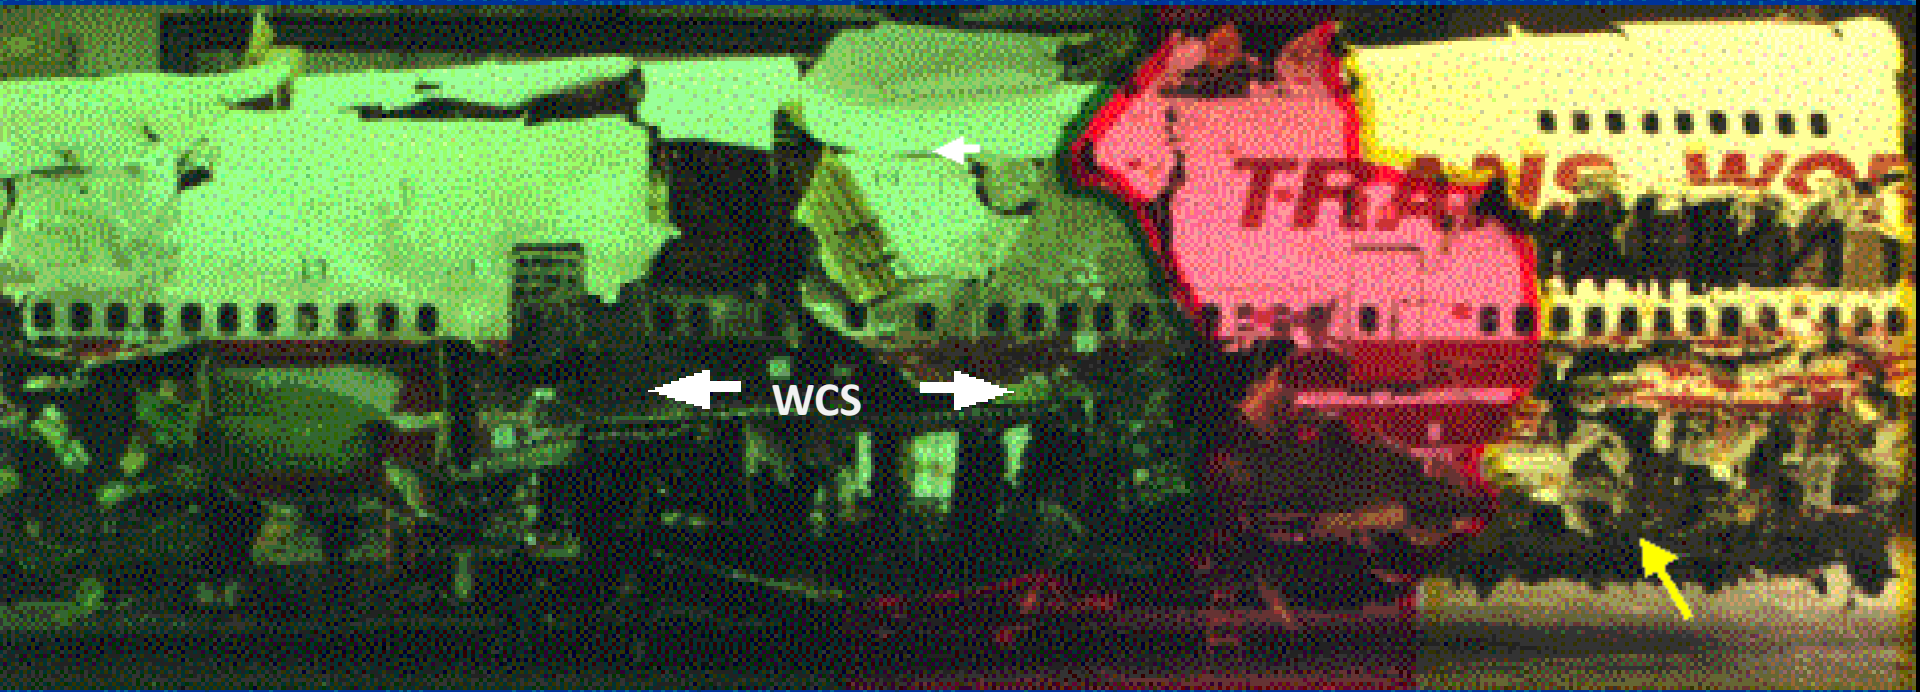
WCS

Spanwise beam 3 fractured at its upper end, then rotated forward

Front spar fractured, progressed downward, and entered the fuselage at stringer 40R

“Early” fuselage fractures created a hole in the belly of the airplane

Additional fuselage fractures allowed release of the nose portion

Main portion of the airplane (most of the wing center section, wings, aft fuselage, and tail) remained intact, then climbed and rolled

Main portion broke up further as speeds and loads increased during descent
